**Remediating and Monitoring
White Phosphorus Contamination
at Eagle River Flats
(Operable Unit C),
Fort Richardson, Alaska**

FY 00 Report

August 2001

**U.S. ARMY ENGINEER RESEARCH AND DEVELOPMENT CENTER,
COLD REGIONS RESEARCH AND ENGINEERING LABORATORY
Charles M. Collins and David W. Cate, Report Editors**

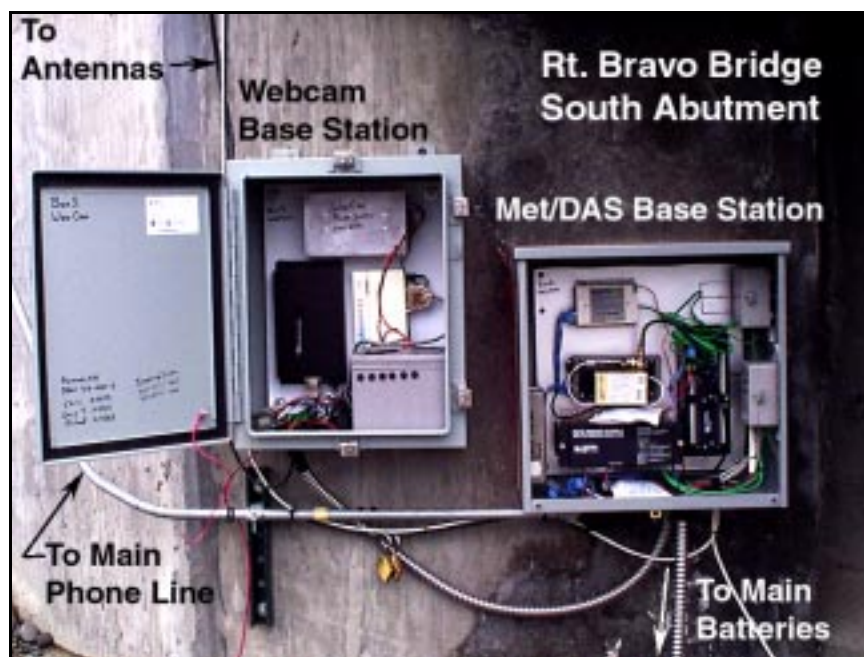
Figure III-1-2. Rt. Bravo Bridge remote monitoring base station.

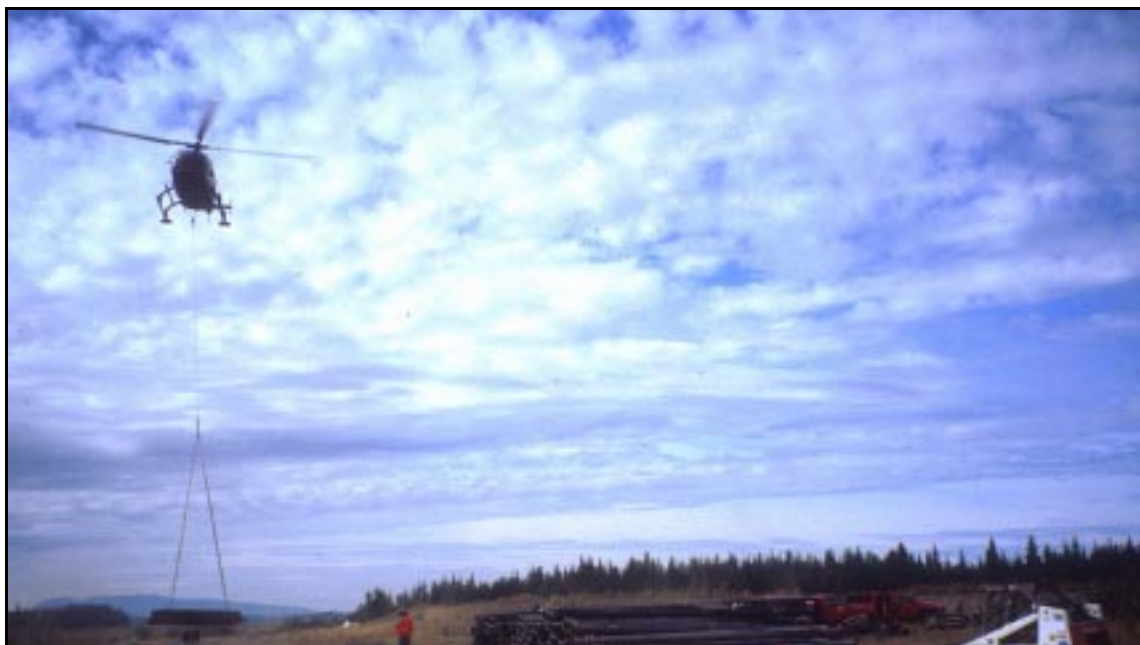
Figure III-1-3. Retrograde of pipe to EOD Pad using slings.

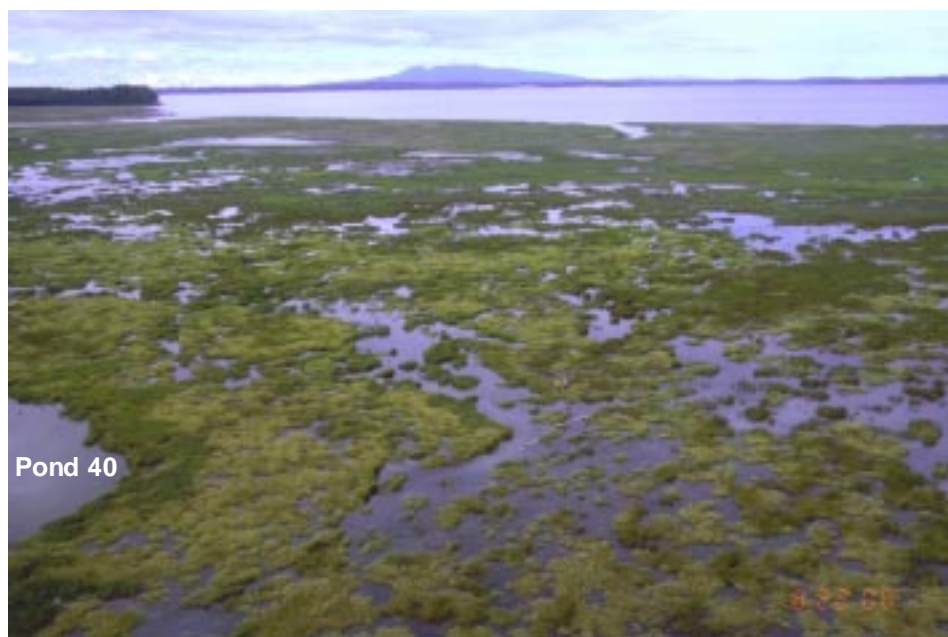
Figure III-3-4. Aerial oblique view of Area C/D north of Pond 40 from which grid composite samples were collected in 2000. No white phosphorus was found. (Photograph taken 22 August 2000.)

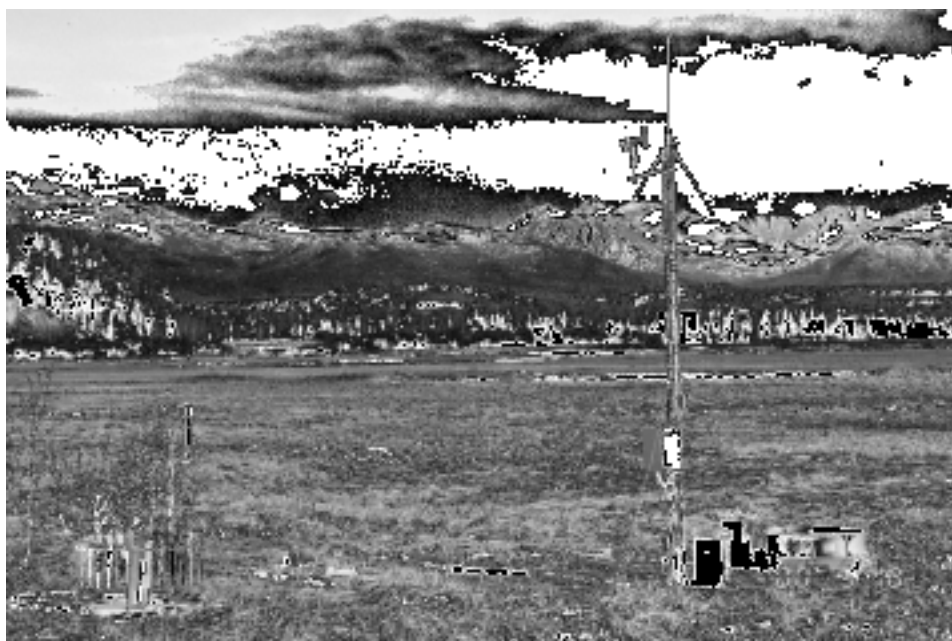
Figure III-4-1. Eagle River Flats meteorological station located off the edge of the EOD Pad. The 4-m tower is located in the right center, the 1.22-m-diameter evaporation pan is located to the right, and the shielded rain gage is located to the left.

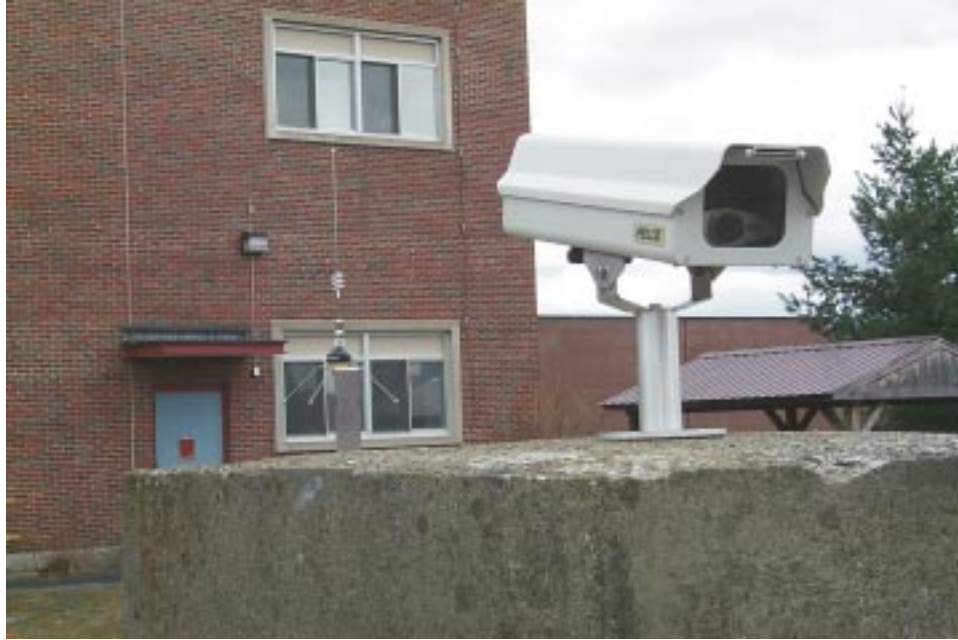
Figure III-5-2. Axis 200+ camera.

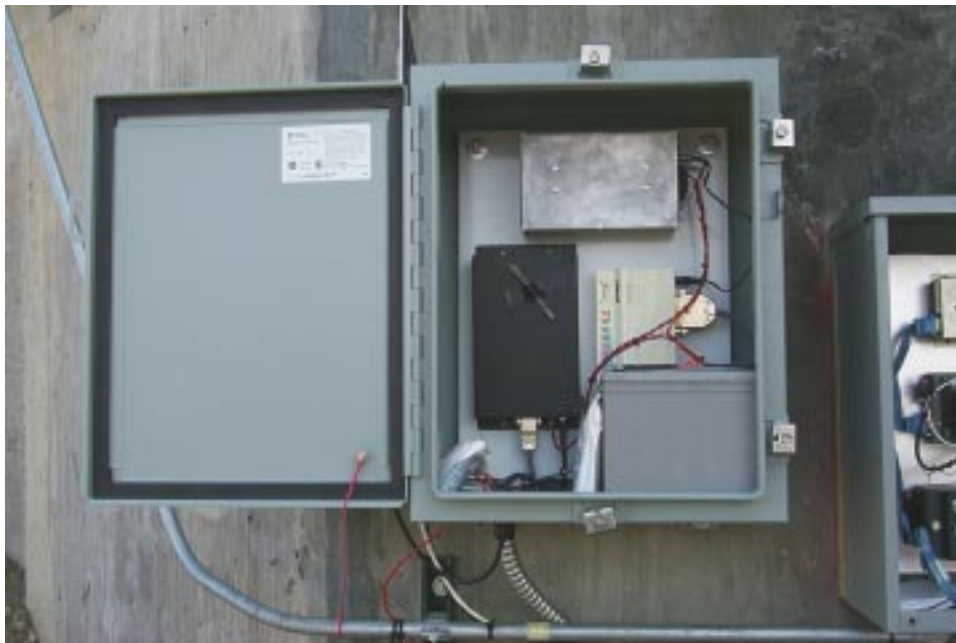
Figure III-5-5. Base station.
